# RESTAURACIÓN DE LA TORRE DE CALETES

## RESTORATION OF THE TOWER OF CALETES

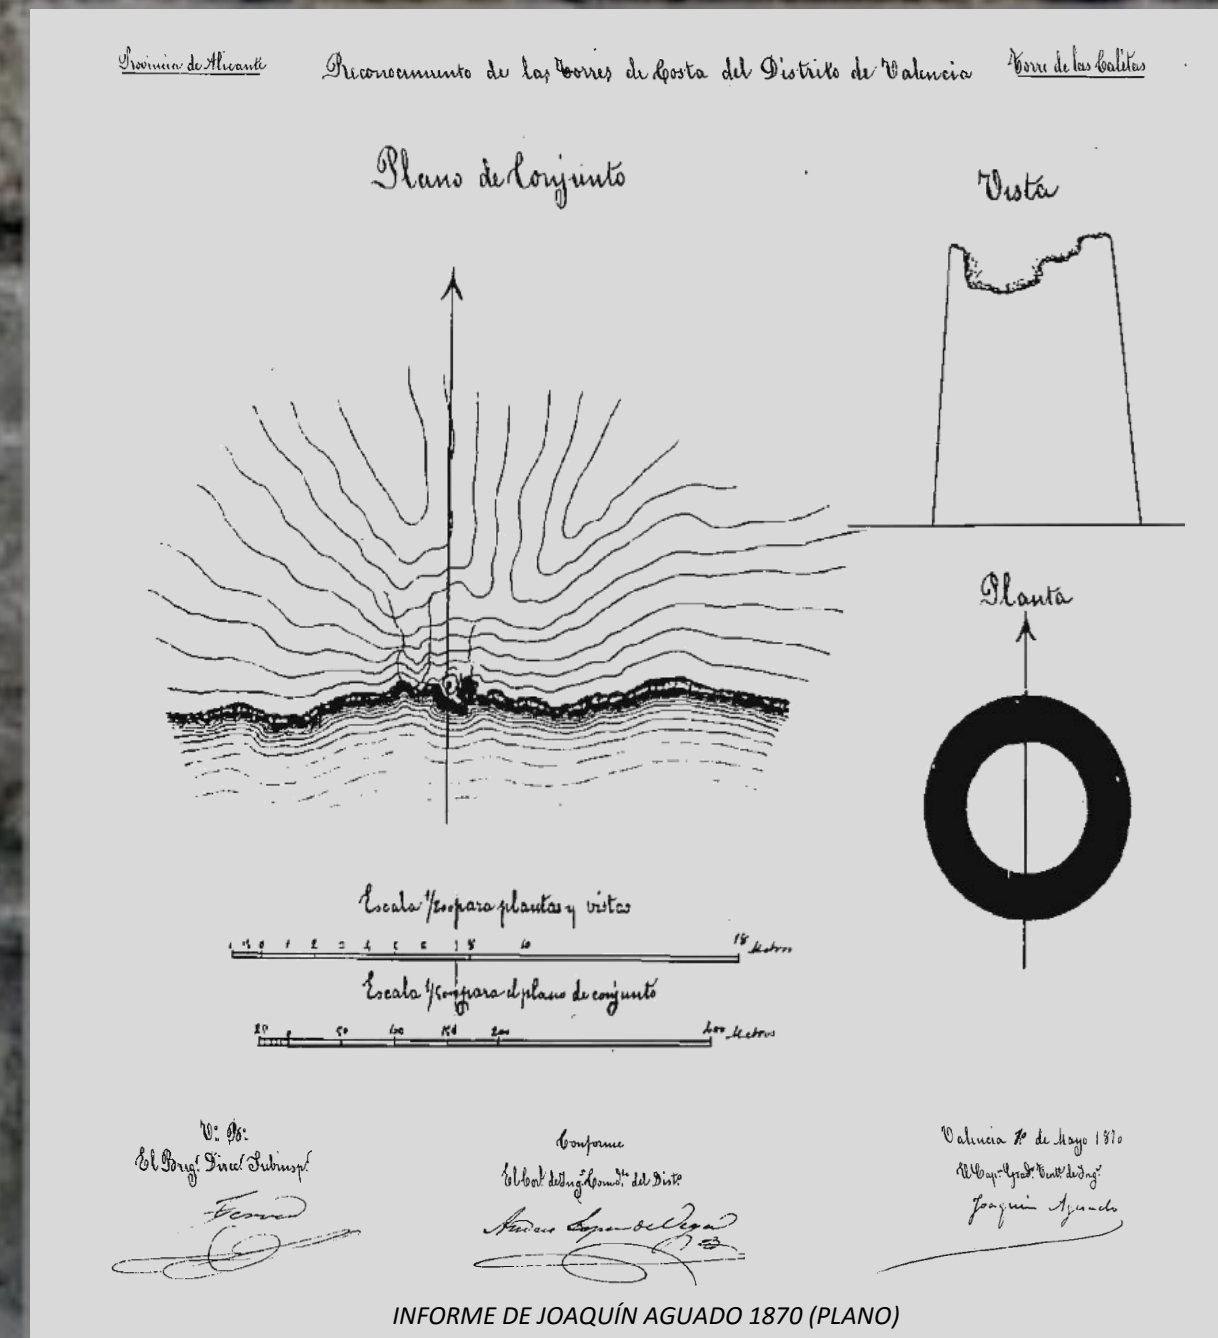
Con toda probabilidad, cuando se construyó la torre, se podría transitar en torno a su perímetro. Sin embargo, el desprendimiento de bloques de roca en el frente del acantilado ha hecho que se vaya perdiendo parte de superficie del macizo llegando al estado actual. La evolución del talud es tal que el borde superior del mismo se encuentra prácticamente alineado con el pie del torreón.

In all likelihood, when the tower was built, it was possible to walk around its perimeter. However, the detachment of blocks of rock from the cliff face has caused part of the surface of the massif to be lost, which has led to its current state. The slope has developed in such a way that its upper edge is practically aligned with the foot of the tower.

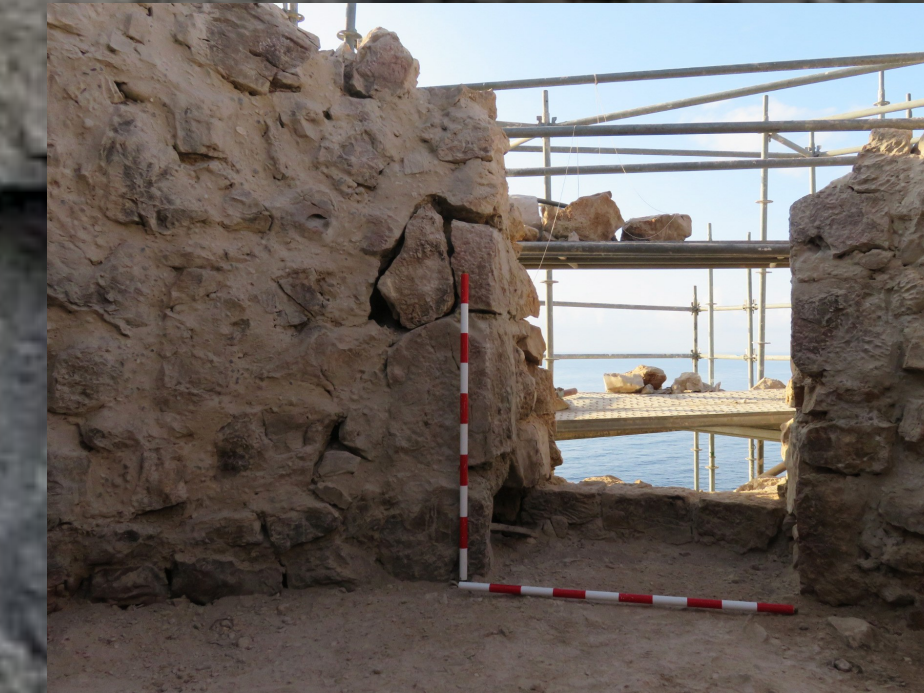
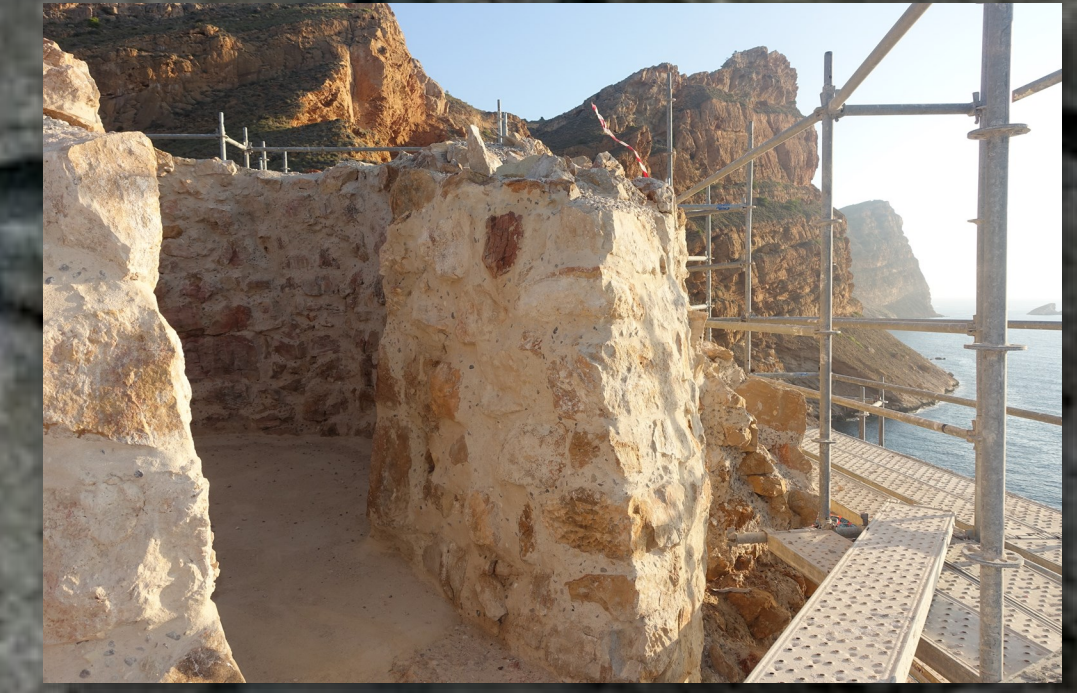
Durante la intervención se ha podido constatar la existencia de una terraza superior, hoy perdida, donde se ubicarían los cañones. Tras retirar los derrumbes del cuerpo central ha aparecido intacta la cámara interior de la torre y el acceso original así como dos troneras, una colapsada que se ha reconstruido, y una segunda que ha podido recuperarse. En la zona más alta se ha encontrado lo que podrían ser los restos de unos matacanes.

During the intervention it was possible to confirm the existence of an upper terrace, now lost, where the cannons would have been located. After removing the ruins of the central body, the inner chamber of the tower appeared intact, as well as the original access and two embrasures (one collapsed, which has been reconstructed, and a second one that has been recovered). In the top part has been found what could be the remains of some machicolations.
