# RESTAURACIÓN DE LA TORRE DE CALETES

## RESTORATION OF THE TOWER OF CALETES

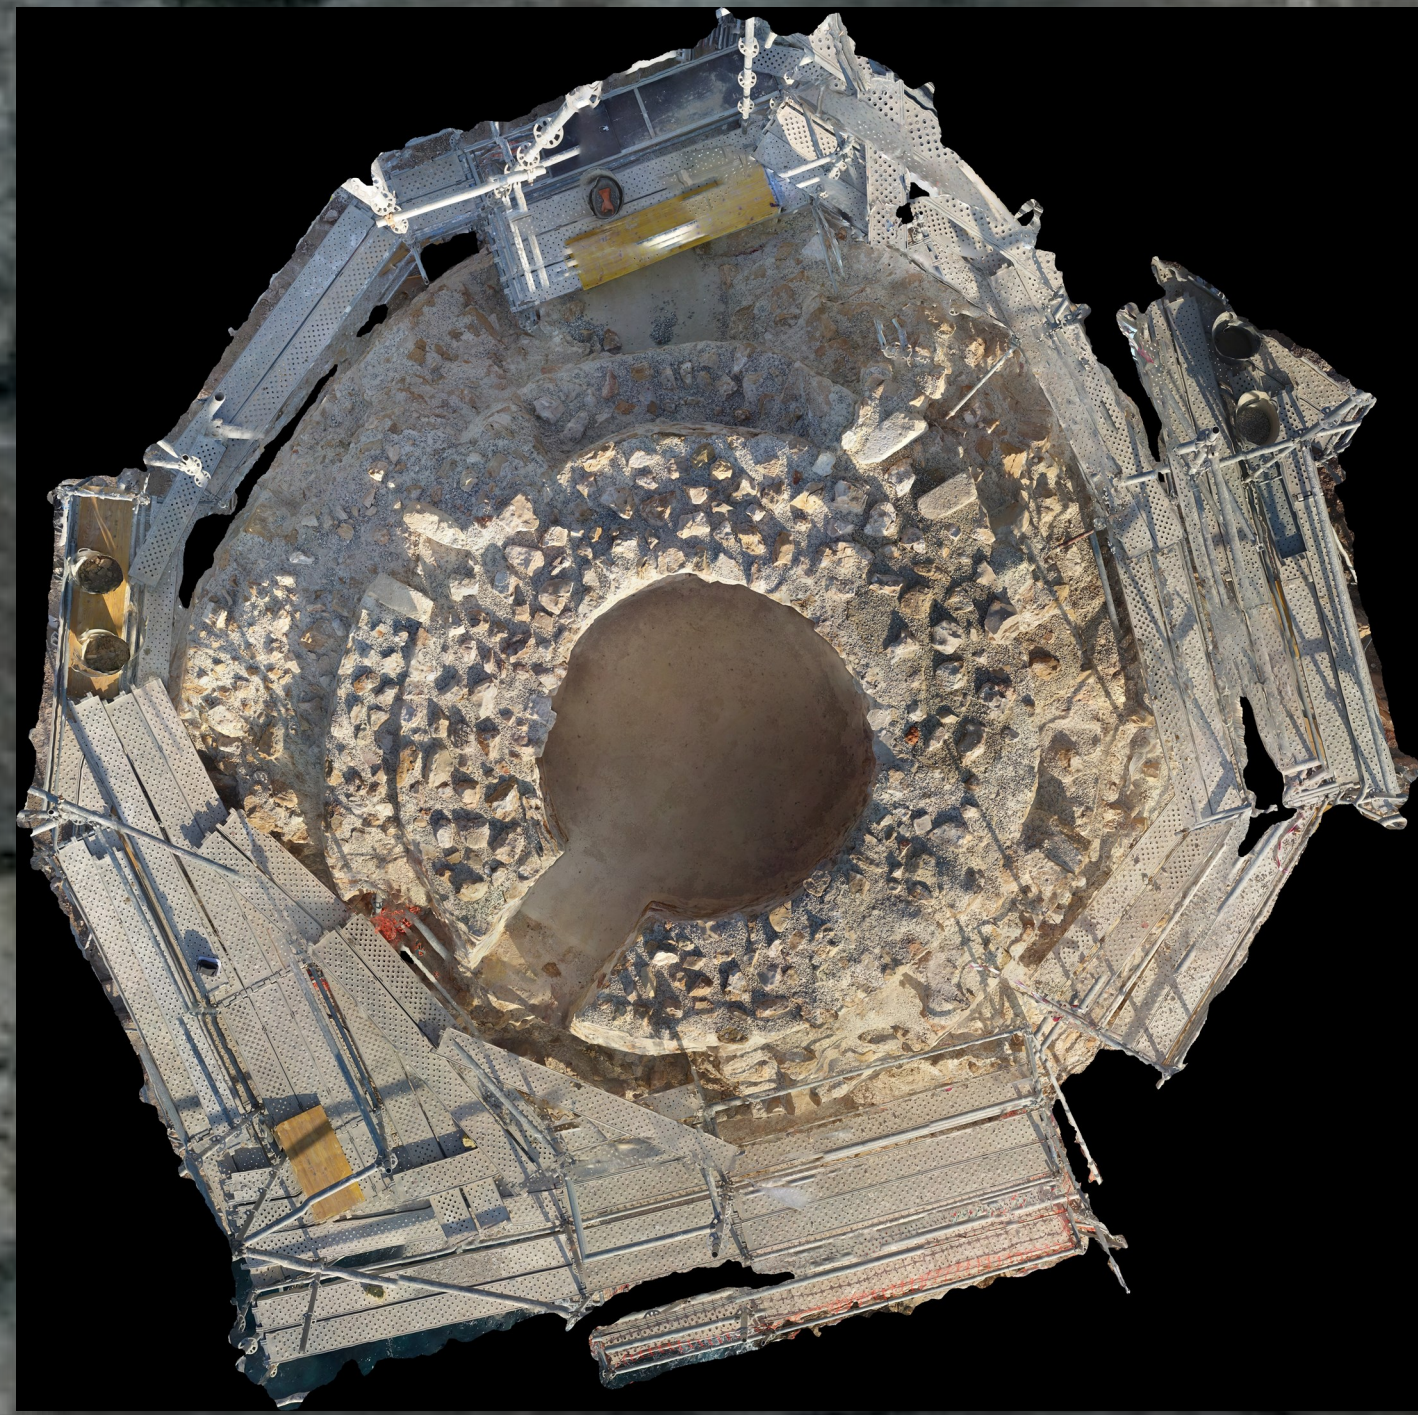
La torre de Caletes se conservaba en estado de ruina como una torre desmochada, faltándole una porción superior. No se conoce documentación gráfica histórica de su configuración, salvo un plano de 1870 del ingeniero Aguado, cuando ya había sido asediada, bombardeada e incendiada. Su morfología guarda mucha similitud con la torre del Xarco, situada más al sur en La Vila Joiosa

The tower of Caletes was kept in a state of ruin like a tower that had been abandoned and lacked an upper part. Historical graphical documentation of its configuration is not known, except for a plan of 1870, belonging to the engineer Aguado, when it had already been besieged, bombed and burned. Its shape is very similar to the Torre del Xarco, located further south in La Vila Joiosa.

Para su restauración se han recalzado muros, retirado morteros no originales y se han consolidado las fábricas. Para devolver la geometría circular desaparecida se ha elevado el volumen conservado del tercer anillo. Para los morteros se han empleado materiales tradicionales como la cal, combinando los áridos finos con gravas y cantos rodados, recuperando las mezclas originales y el cromatismo de las mismas.

As part of its restoration, some walls have been reinforced, mortars have been removed and the masonry has been consolidated. To recover the missing circular geometry, the volume of the tower's third ring has been increased from its original size. For the mortars, traditional materials such as lime have been used and fine aggregates have been combined with gravels and boulders. The original mixtures and their colouring have been retained.

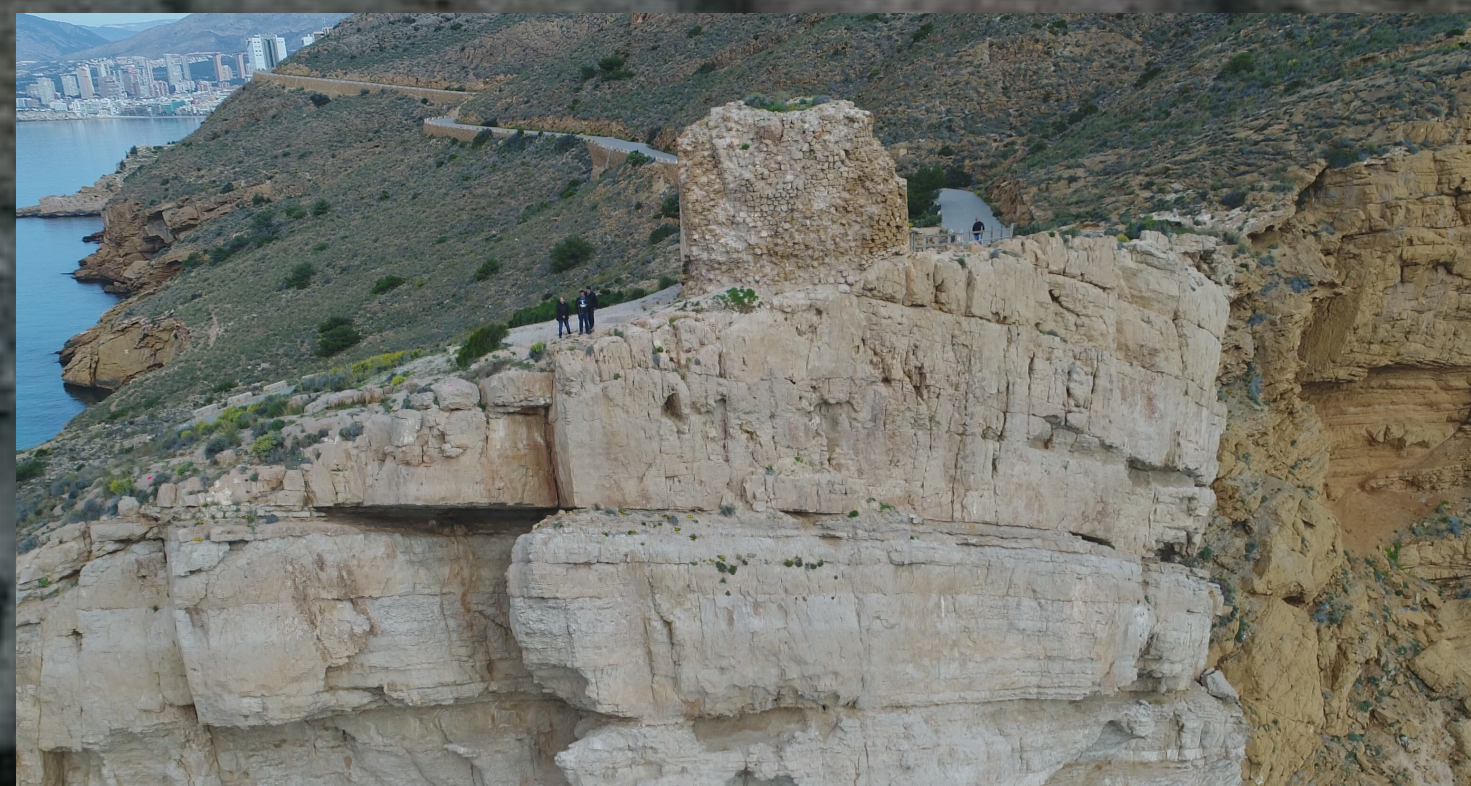
Con toda probabilidad, cuando se construyó la torre, se podría transitar en torno a su perímetro. Sin embargo, el desprendimiento de bloques de roca en el frente del acantilado ha hecho que se vaya perdiendo parte de superficie del macizo llegando al estado actual. La evolución del talud es tal que el borde superior del mismo se encuentra prácticamente alineado con el pie del torreón.

In all likelihood, when the tower was built, it was possible to walk around its perimeter. However, the detachment of blocks of rock from the cliff face has caused part of the surface of the massif to be lost, which has led to its current state. The slope has developed in such a way that its upper edge is practically aligned with the foot of the tower.
